SECURING/DEMOLISHING BUILDINGS
MEDFIELD STATE HOSPITAL, MEDFIELD MA

EXECUTIVE SUMMARY

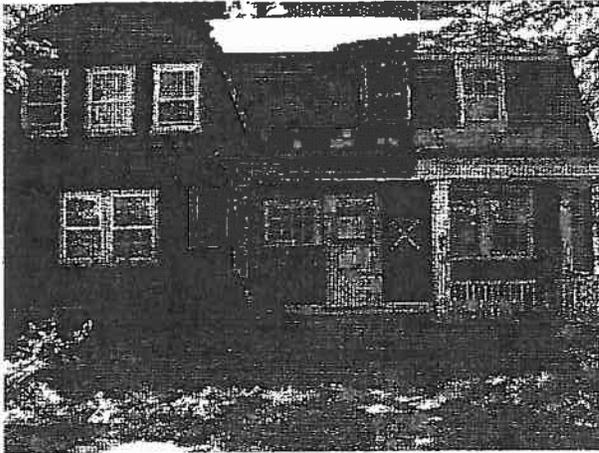
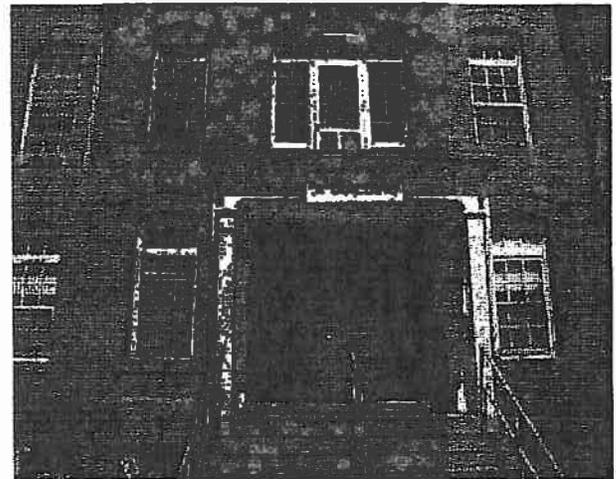
In September 2011, CDW conducted a visual survey to identify and observe 22 ancillary buildings on the Medfield State Hospital campus that were unsecured. The number of windows, doors, and other building openings were quantified.

The Clark Hospital Building has exceeded its useful life and does not contribute to the Medfield State Hospital Historic District. It is recommended that this building be demolished. The recommended course of action for ancillary buildings is to temporarily secure all openings (windows, doors, hatches, etc.) from access by authorized personnel or wildlife, in accordance with DCAM standards. The imminent public safety hazards from the crumbling porches require that they be demolished and taken off-site.

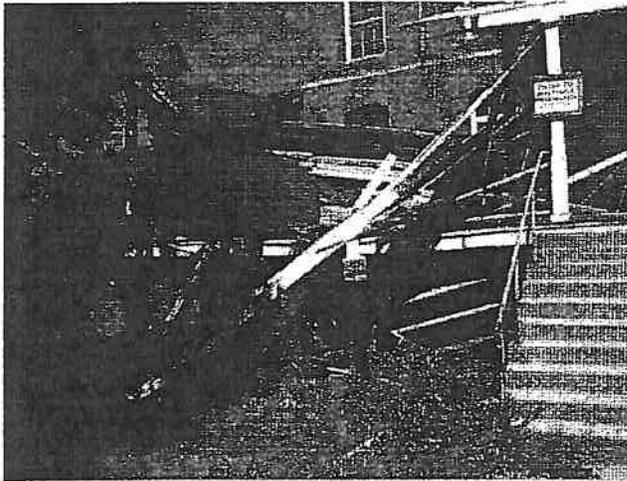
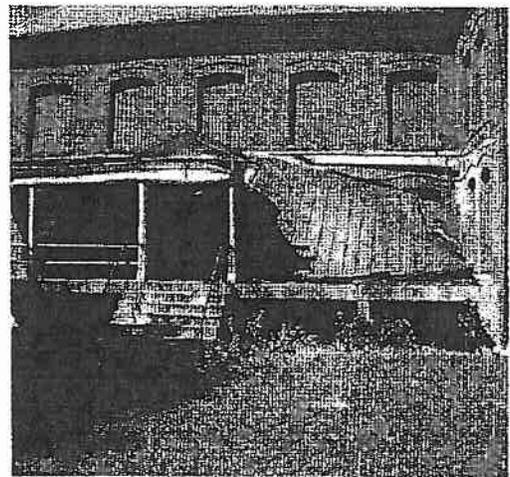
During the course of the survey of ancillary buildings, several wooden porches were also observed in extreme disrepair. These were measured and documented.
