SECURING/DEMOLISHING BUILDINGS
MEDFIELD STATE HOSPITAL, MEDFIELD MA

EXECUTIVE SUMMARY

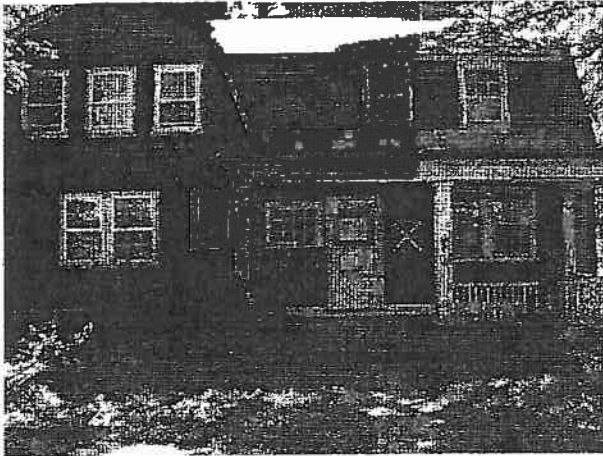
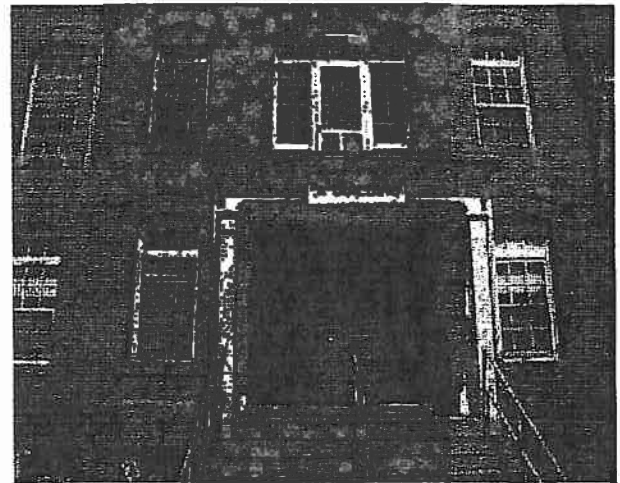
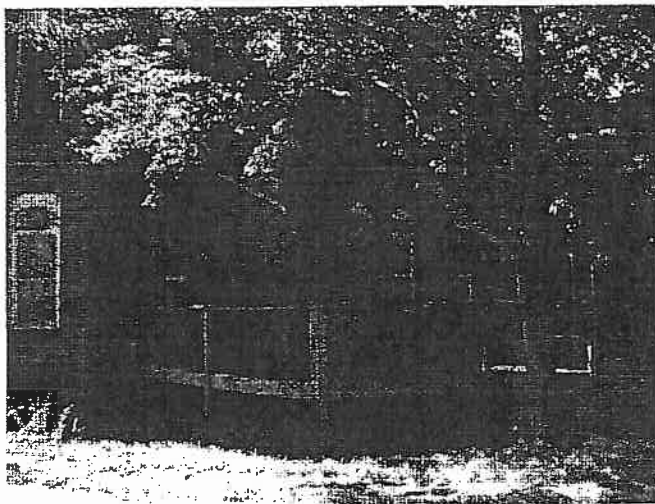
Ancillary Buildings

In September 2011, CDW conducted a visual survey to identify and observe 22 ancillary buildings on the Medfield State Hospital campus that were unsecured. The number of windows, doors, and other building openings were quantified.

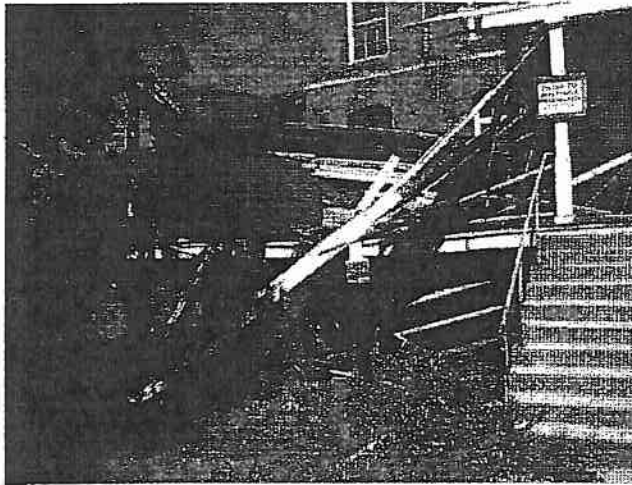
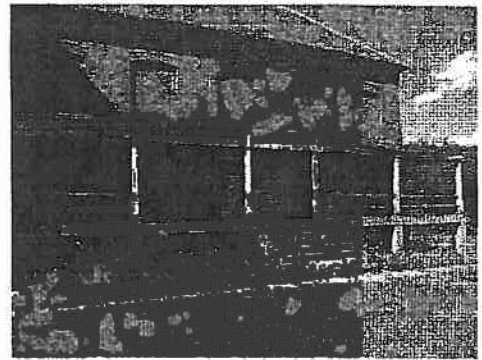
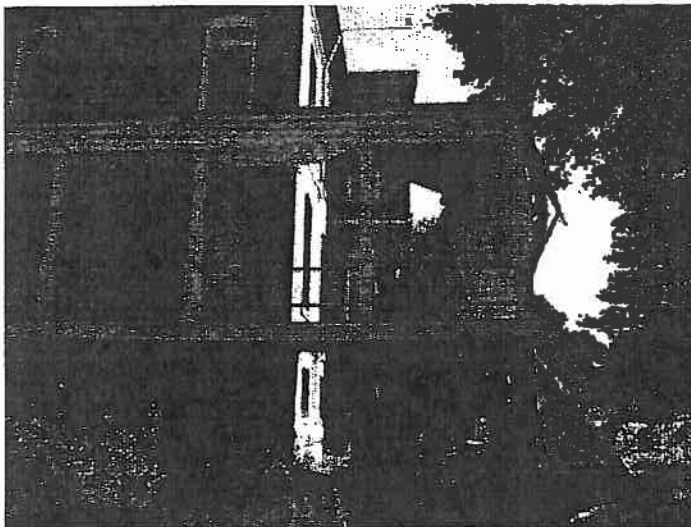
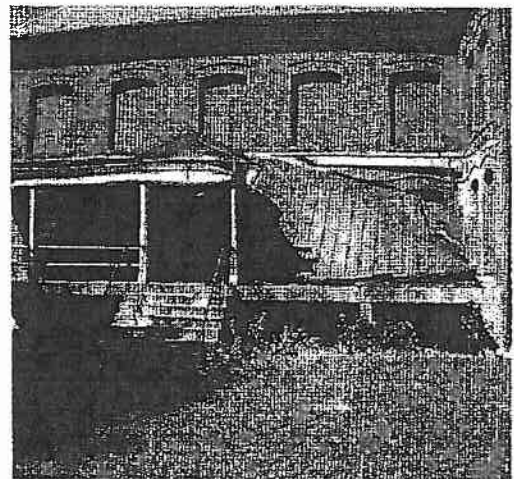
Wooden Porches

During the course of the survey of ancillary buildings, several wooden porches were also observed in extreme disrepair. These were measured and documented.
