Medfield State Hospital, Medfield, Ma
Cultural Arts Facility Feasibility Study
Architectural Assessment

April 5, 2017

DBVW
ARCHITECTS

Table of Contents	I.	Executive Summary	5
	II.	Architectural Assessment & Existing Conditions	
		#22A Administration Building	8
		#24 Lee Hall [Chapel]	11
		#25 The Infirmary [Old research building]	14
	III.	Assessment Summary	18
	IIII.	Conceptual Plan	20
	IV.	Preliminary Estimate Of Probable Construction Cost	30

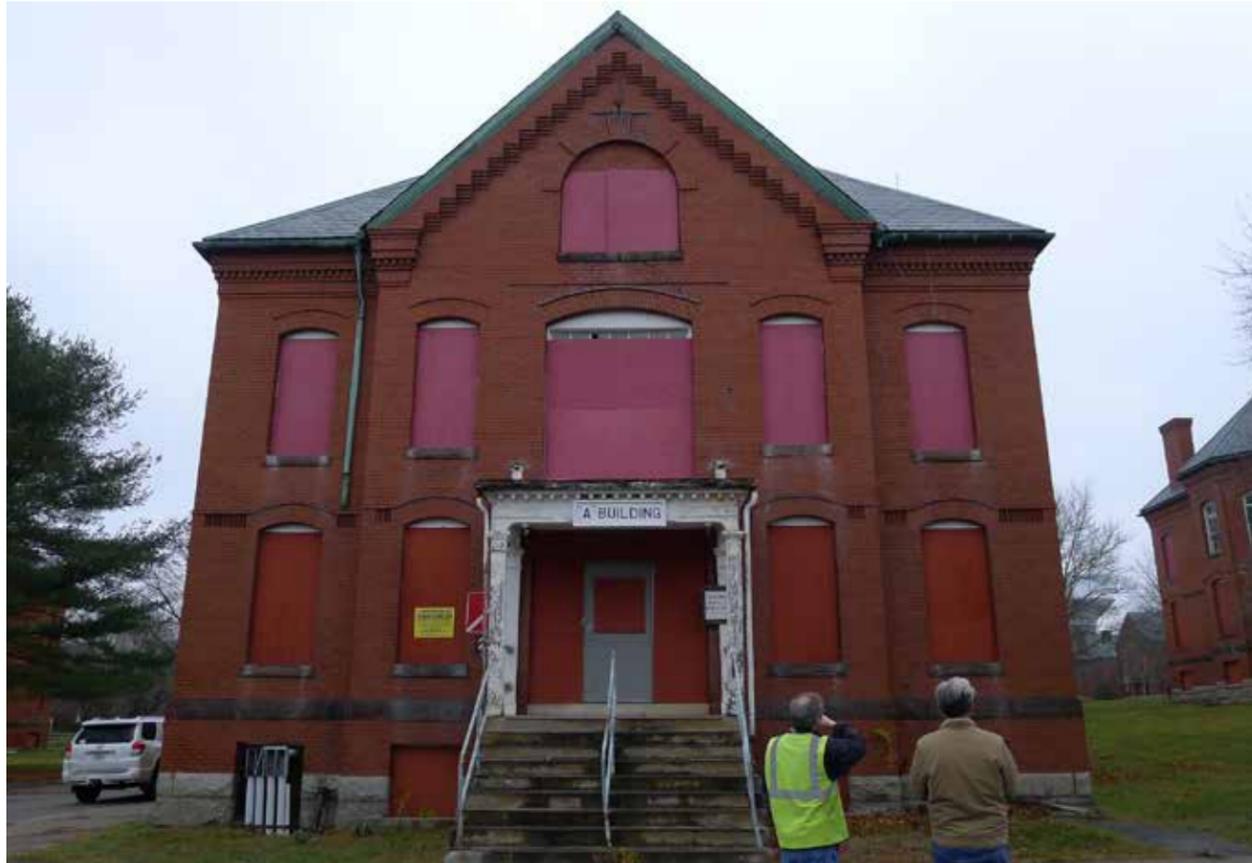
Figure 3. South elevation of building #22A Administration.

The elevated main entry portico on the South facade is intact, but is in need of significant repair. The original steps and rails have been replaced by historically inappropriate cast-in-place concrete steps and steel railings, both of which are in poor condition. On the West facade, there is another set of non-original, deteriorated concrete stairs, leading to a non-original egress door that serves as an exit from the main stairway. Below this stair, there is an areaway with cast-in-place concrete egress stairs leading from the basement level. On the North facade, a third set of non-original concrete stairs exists, but the original wood portico has been removed. On the East elevation, there is a non-original steel fire escape attached to the wall, connecting between third and second story windows.

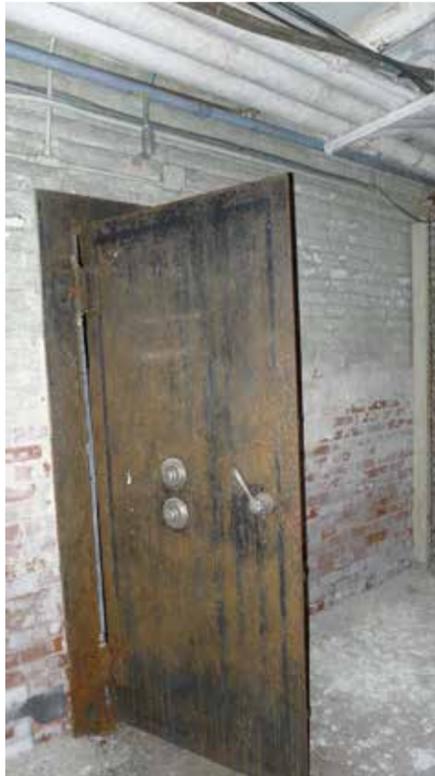
Figure 13. Vault door - basement

Original wood windows contain a one-lite tall fixed transom above a 6/6 or 4/4 double-hung sash. They are mostly present but failing and damaged. Interior casings and sills are solid wood and in fair-good condition. The doors are also in fair-good condition and paneled hardwood. Entry and interior doors have transoms above. Basement doors are clad in steel. There are three vaults, one on each floor and each with original steel doors, which have significant surface rust but could be restored.

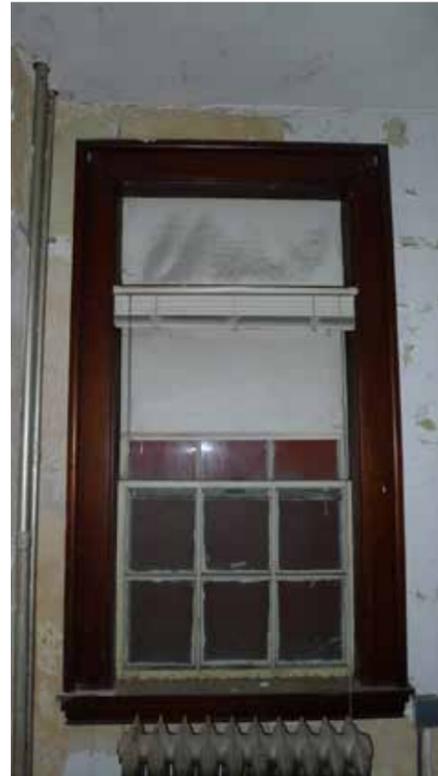
Figure 14. Typical double-hung window

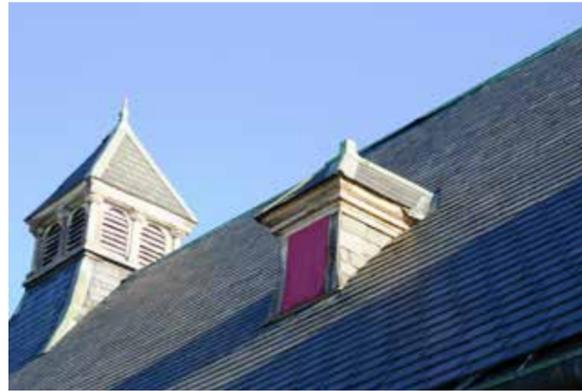
Figure 21. Slate roof, cupola and dormer

2.2 Exterior- Roof: The roof is clad in slate shingles, copper valley and ridge flashings, copper gutters and decorative gable cornice moldings, all of which appears to be original. Additionally, there is an original vented cupola with a decorative copper finial at the North end of the roof and a weather vane atop the large clock tower on the Southwest corner. Slate shingles are missing or replaced/patched in many areas, and many others appear to be loose. Based on evidence of substantial water infiltration at the valley between the East side of the clock tower and the South Gable, the copper flashing (and possibly roof shingles) appear to be damaged at this area. Copper gutters are somewhat

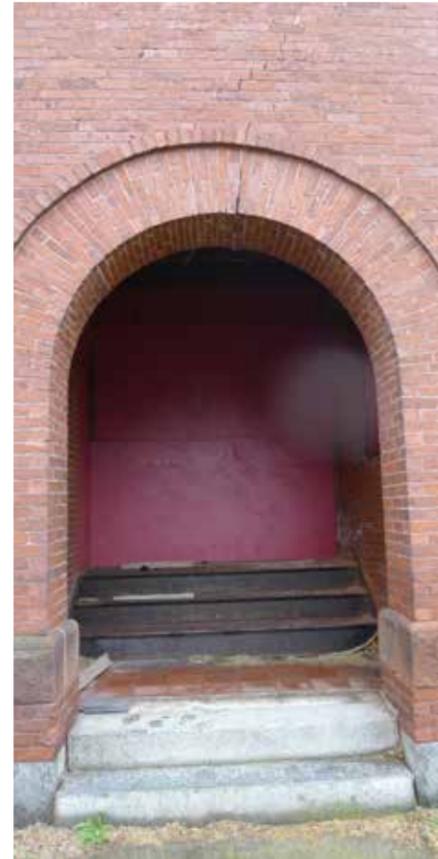
Figure 23. Recessed entry; settlement cracking above brick arch

2.1 Exterior - Walls: The building envelope is in fair -good condition. The brick masonry and brick and granite clad foundation requires re-pointing, isolated areas of partial disassembly and re-building (at some arches, scupper boxes, for example) and cleaning. Diagonal settlement cracks were apparent in several locations, but did not appear to be worsening. In the 1950's there was structural work completed adding steel reinforcing to wood-framed roof trusses at the main hall. Evidence of this work is apparent on the East and West elevations, where steel plates and through-wall tie bolts are spaced along

the wall, below the gutter. Presumably, this work was completed to address a concern that the wood trusses were sagging, exerting pressure on the masonry walls and pushing them out at the top. In sighting up the exterior wall faces, there is little evidence of bulging or spreading and the condition appears to be stable. The exterior slate floors at the arched covered entries are in poor-fair condition and require substantial reconstruction. A small, wooden addition to the north facade, which provides cover for a staircase to the basement, is in fair condition and requires substantial repair, as does the stairway. All window openings have been boarded up with plywood so exterior evaluation of windows was not possible.

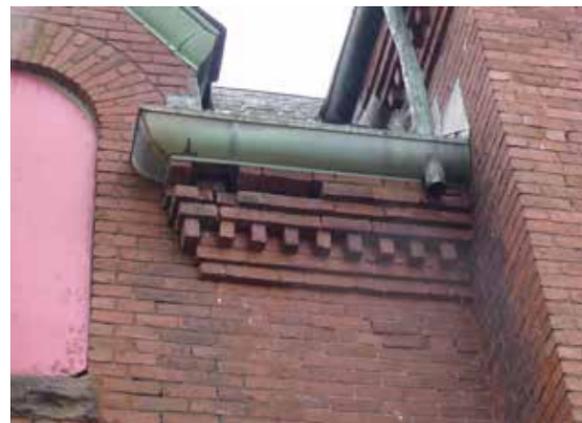
Figure 22. Missing and damaged masonry detailing; copper gutters

intact, though the condition could not be determined. Copper downspouts have been removed in many areas however, resulting in accelerated mortar deterioration at areas under gutter outlets. Dormers, cupola and clock tower faces all require carpentry repairs.

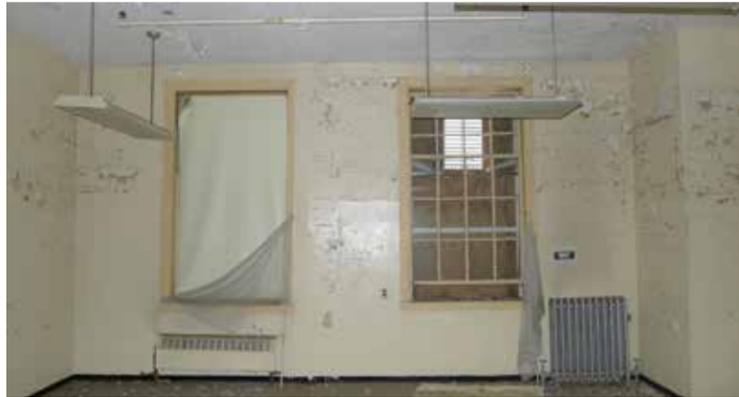
Figure 38. Typical 2nd floor double hung windows

3.7 Interior - Windows/Doors: The main East and West entry doors have been replaced by non-original aluminum and glass doors with a sidelight and transom. At the east end, a non-original set of half metal, half glass doors with metal frame separates the entry vestibule from the corridor. The west corridor has a set of original wood and glass doors with transom above and wood frame. The first floor interior doors are a mixture of non-original metal and wood, flush panel doors with no glass. The second floor doors, many of which appear to be original, are generally two-paneled (some with half glass) with two-lite transoms. There are several types of windows in the building in mostly poor-fair condition. The basement has mostly 8/8 wood double hung windows (set into window wells to maximize daylight) with some smaller units. The windows in the upper floors are primarily double hung's of various sizes, divided in several lite configurations, including 8/8 and 8/12. There are more windows on the upper floor than on the main floor, though the windows are larger on the main floor.

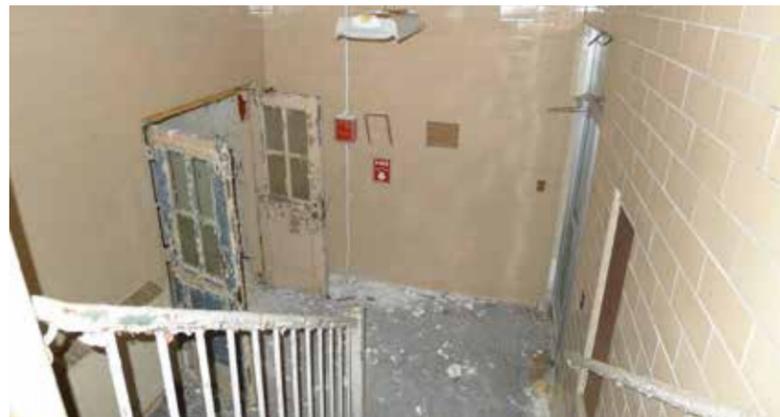
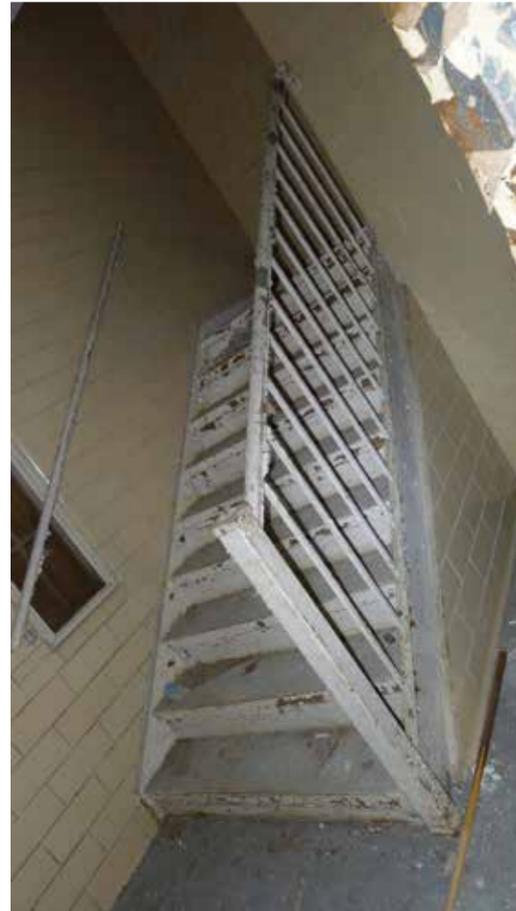
Figure 45. East stairway (non - original)

Figure 46. East stairway (non - original)

3.8 Interior - Stairs: There are stairways at each end of the central corridor. The wood stairway connecting all three levels on the West end appears to be original and in good condition. The steel-framed stairway at the East end appears to be a later addition and is also in good condition. This stairway only connects the first and second floors. The second means of egress from the basement at this end of the building is via an exterior areaway stair.

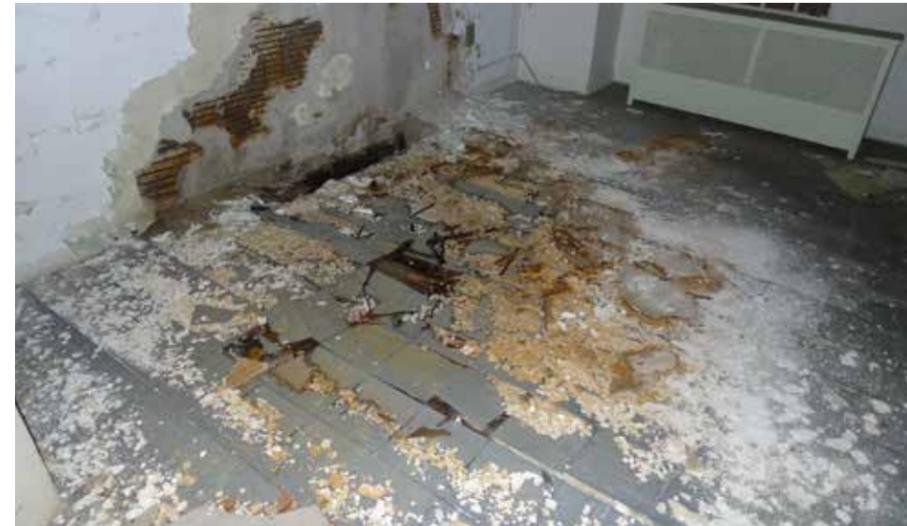
The sloped perimeter of the roof is covered in the original slate shingles. Many of the shingles have been damaged, some are missing and it appears that some areas have been patched in more recent years. Much of the valley flashing on the roof is damaged or is missing, resulting in water infiltration and damage to wood structural framing at those locations. The upper flat roof appears to be a composite built-up roof. Though there are no apparent roof

Figure 49. Water damage and deterioration from roof leak

leaks from this flat section, it appears to be well beyond its expected service life and should be replaced, along with all transition flashing to sloped roof.
