Medfield State Hospital, Medfield, Ma
Cultural Arts Facility Feasibility Study
Architectural Assessment

April 5, 2017

DBVW
ARCHITECTS

Table of Contents	I.	Executive Summary	5
	II.	Architectural Assessment & Existing Conditions	
		#22A Administration Building	8
		#24 Lee Hall [Chapel]	11
		#25 The Infirmary [Old research building]	14
	III.	Assessment Summary	18
	IIII.	Conceptual Plan	20
	IV.	Preliminary Estimate Of Probable Construction Cost	30

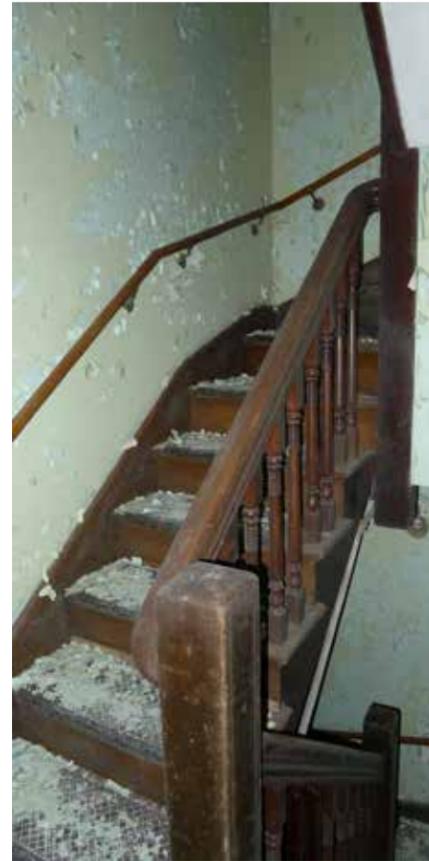
Figure 9. Secondary stair first floor landing

There are two original wood staircases, both on the west side of the central hallway. The main stair runs from the basement to third floor and at some point an exit door was added at the first floor, presumably to improve code compliance. The second narrower secondary stair connects from the first to third floor and includes iron treads and risers on the lower run. Both are in fair-good condition, with original features intact. Re-use of stairs is possible, however they will require evaluation for code compliance (there is additional consideration for acceptance of continued use of existing stairs within historic structures). However, based on the positioning of the two stairways within the overall plan, it may be necessary to provide an additional, remotely located stairway for future re-use of building (this would also make possible the elimination of the existing, non-original exterior fire escape on the East elevation). This requirement will need to be evaluated based on the specific use and proposed plan.

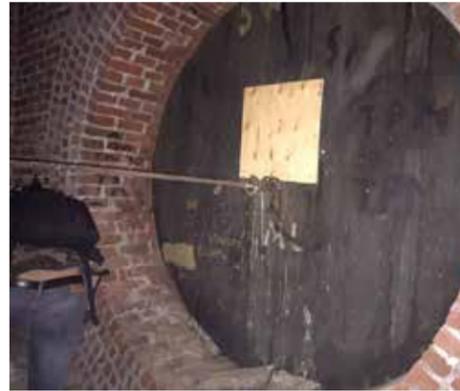
Figure 24. Back of wooden clock face and movement mechanism

intact, though the condition could not be determined. Copper downspouts have been removed in many areas however, resulting in accelerated mortar deterioration at areas under gutter outlets. Dormers, cupola and clock tower faces all require carpentry repairs.

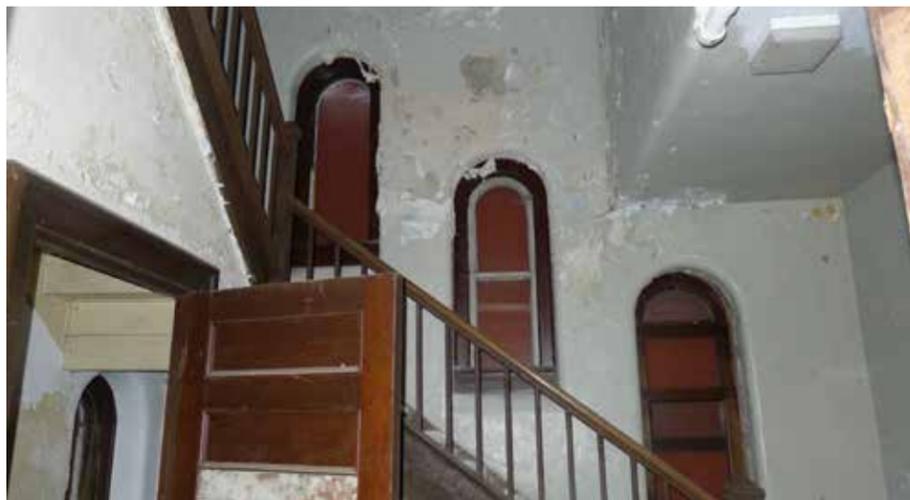
Figure 32. Replacement and original windows - southeast stair

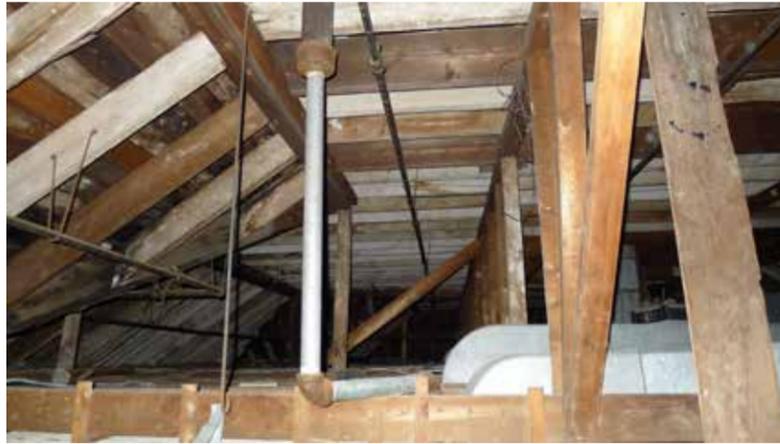
Figure 44. Wood roof framing - attic

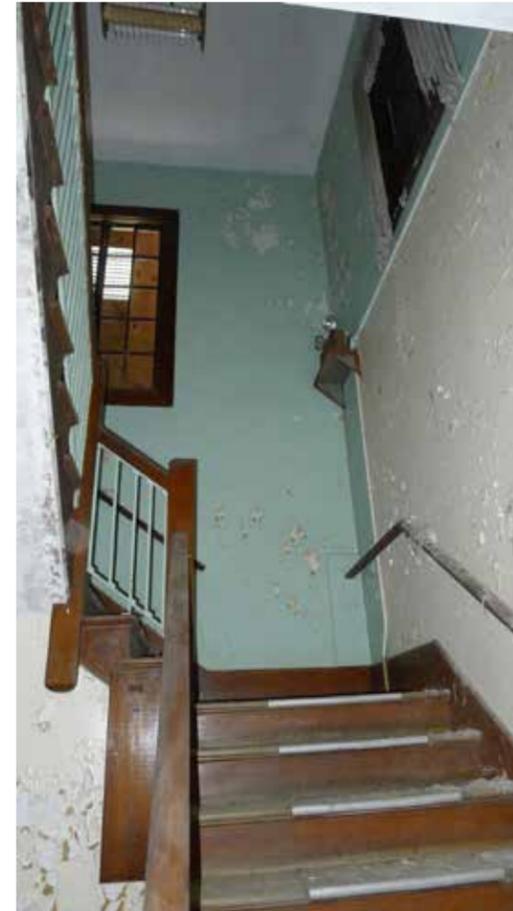
Figure 47. West stairway

3.8 Interior - Stairs: There are stairways at each end of the central corridor. The wood stairway connecting all three levels on the West end appears to be original and in good condition. The steel-framed stairway at the East end appears to be a later addition and is also in good condition. This stairway only connects the first and second floors. The second means of egress from the basement at this end of the building is via an exterior areaway stair.
